Assessing the Efficacy of Fish Presence and Species Composition at GIS-Derived Stream-Road Crossings in two Low Gradient Headwater Streams in Downeast Maine

Scott Craig¹
Iris Lowery²

Upper Machias River Study Area's

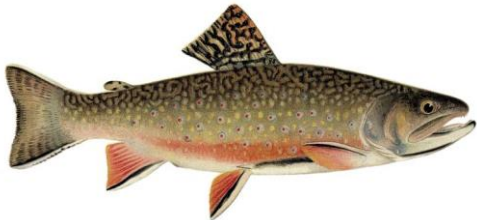
Fish Observed at GIS Derived Stream-Road Crossings

(n=40)
